Project: TNDR 154-2015 Consultancy Services for Dynamic Modelling and Studies of Oman Power System

**Report after competition of
installation phase**

September 2016

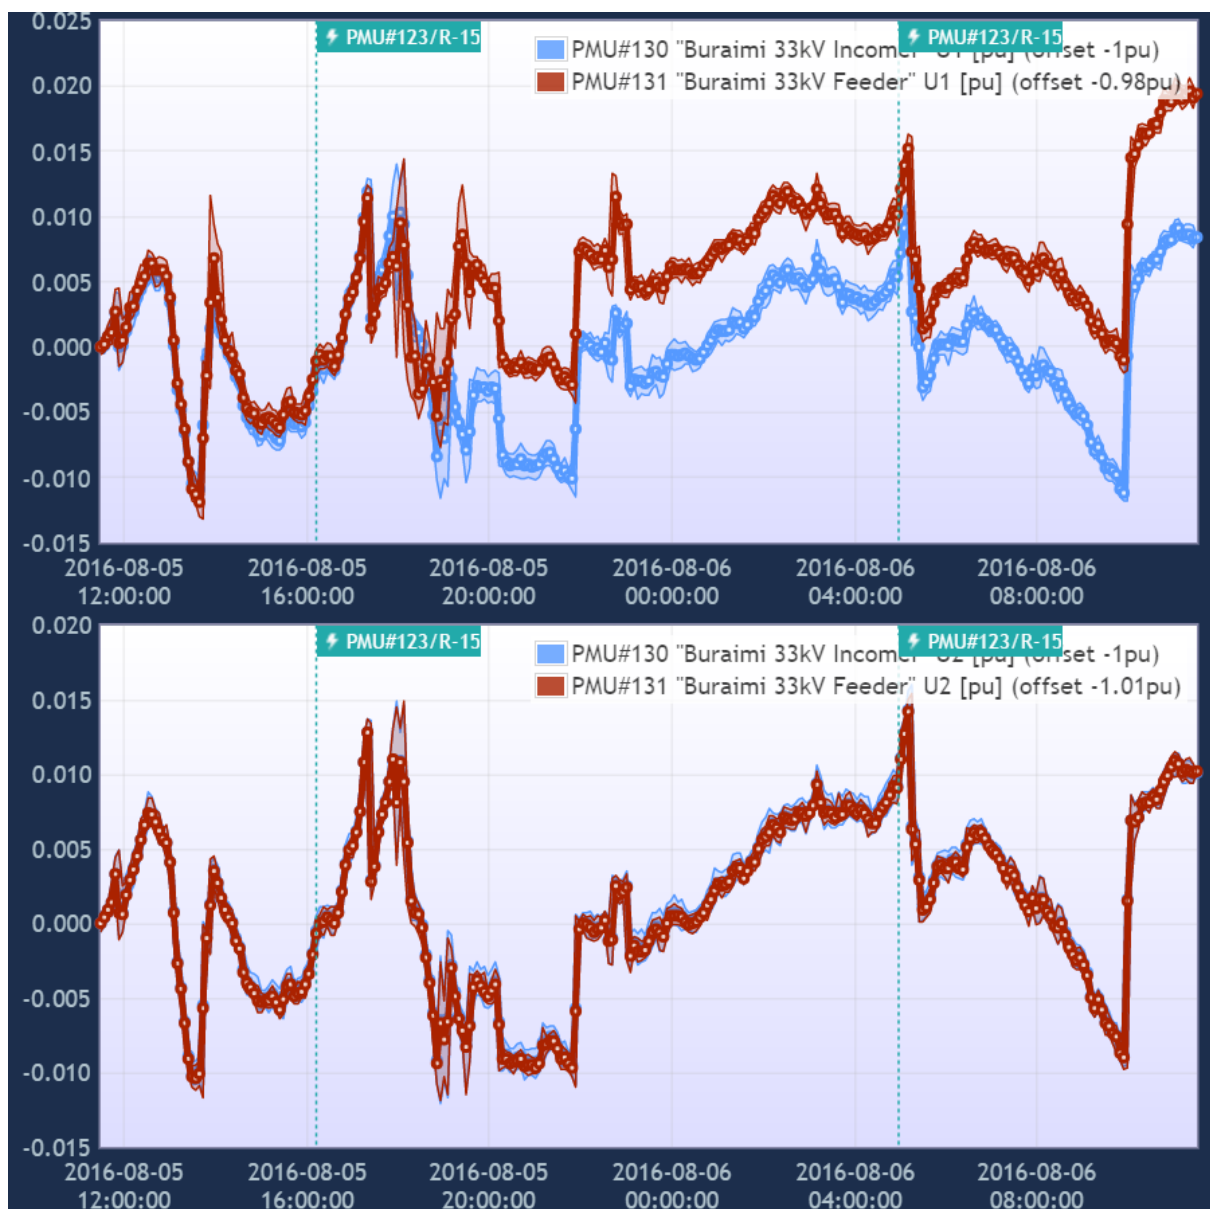
Figure 3: Phase 1 and 2 voltage magnitudes in Rusail-Buraimi gs/s, blue – incomer, red – feeder

WAMS erected for OETC measurement campaign proved that there is a changing difference in voltage magnitudes and phase between phase 1 voltage measured by incomer and feeder. [Figure 3](#) shows change of voltage magnitudes readings for U1 and U2. “Zero offset” function was activated to emphasize differences. Difference on phase 1 voltages was caused by increased feeder VT signal.

Recorded phenomenon can be induced by problem in primary equipment, deterioration of VT or problem in secondary wiring. Further examination at site is needed to pinpoint real cause.

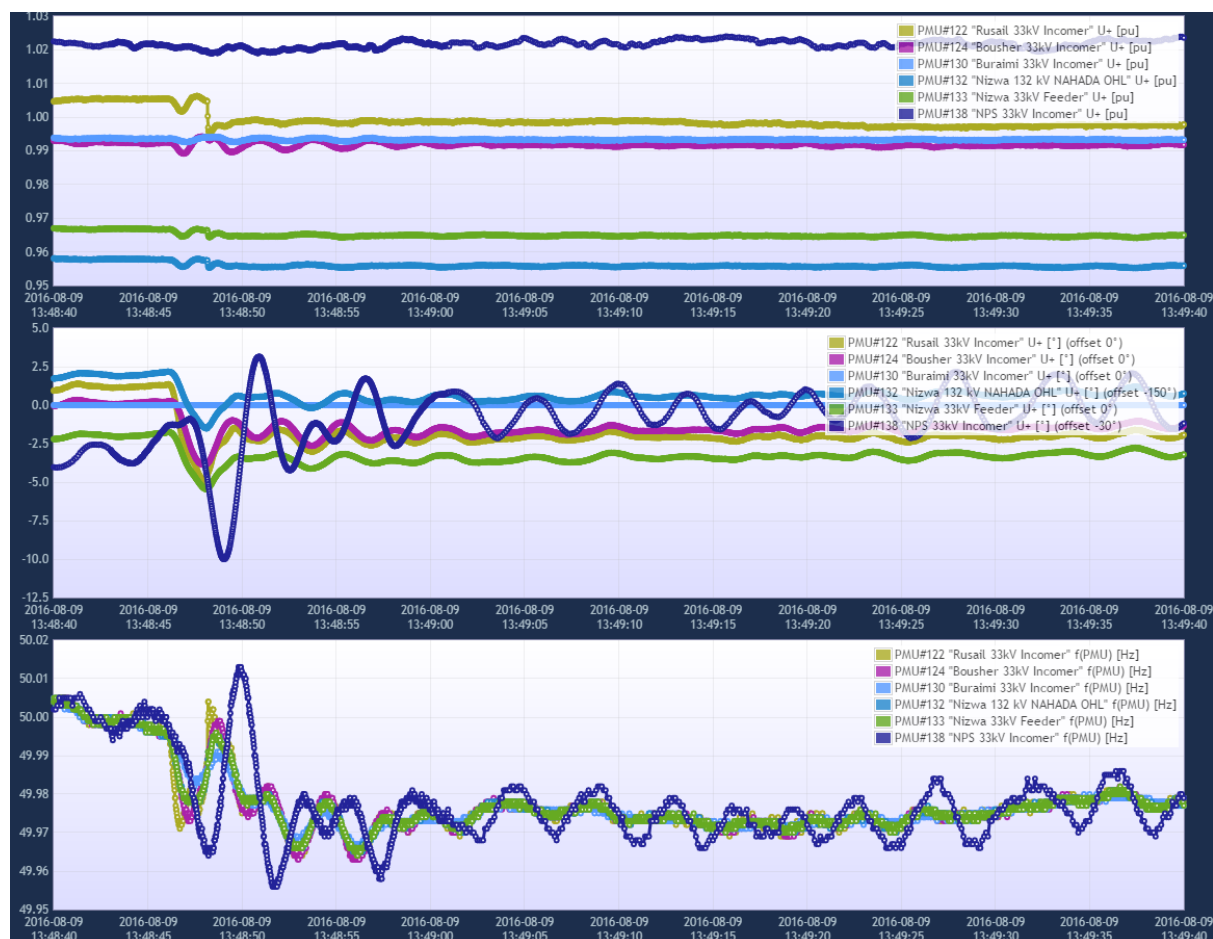
Figure 5: Voltage magnitude, voltage angle and frequency variation recorded at Rusail, Bousher, Buraimi and NPS incomers and Nizwa 132kV and 33kV systems. Referent unit for phase: PMU in Buraimi g/s

Voltage and frequency oscillations were detected on 2016-08-09 13:48:46.300. [Figure 5](#) presents voltage magnitudes, voltage angles and frequency variation recorded at Rusail g/s incomer (PMU#122), Bousher incomer (PMU#124), Buraimi incomer (PMU#130), Nizwa 132 kV Nahada OHL (PMU#132), Nizwa 33 kV feeder (PMU#133) and NPS incomer (PMU#138). Phase angles are presented with angle of PMU in Buraimi g/s used as an angle reference. It is clear that presented dynamics shows system response to disturbances such as generator loss or improper synchronization originated in Rusail area followed by trip and topology change 2 seconds later.

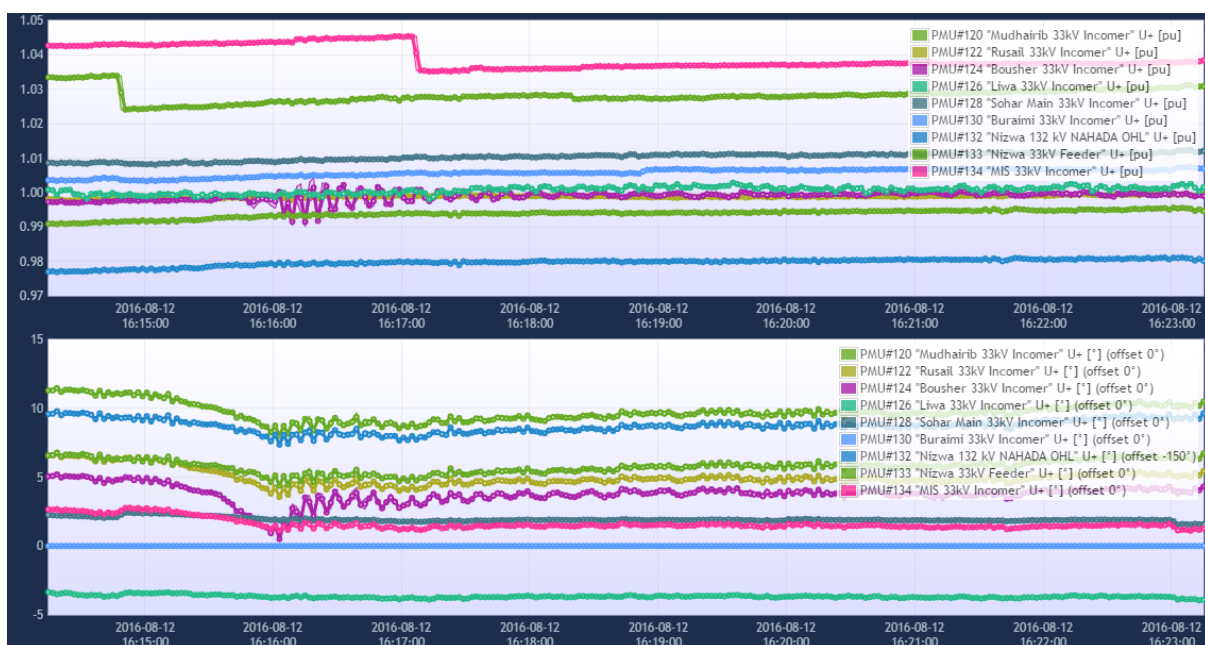
Figure 6: Voltage amplitudes and angles recorded at Mudhairib, Rusail, Bousher, Liwa, Soha Main, Buraimi, Nizwa and MIS grid stations. Angle reference: Buraimi PMU angle.

A small variation in Bousher g/s voltage was detected 2016-08-12 16:16:00 GST. The amplitude of voltage oscillation was 0.0075 pU with duration of about 2 minutes. Recorded data revealed that variation in Bousher voltage was preceded by a misbalance in power flow. Phase angles shift presented on Figure 6 and their change shown on Figure 7 confirm that a significant change in power flow happened. The influence of power flow change was mostly noticeable in Bousher area where phase angle to Bureimi g/s changed from $+5^\circ$ to $+0,6^\circ$ in approx. 2 minutes before voltage oscillation started.
